Case Study

**Vestas France & TotalEnergies –
Dainville Wind Park**

Task:
**Leading Edge Repair (LER)
on 12 turbines**

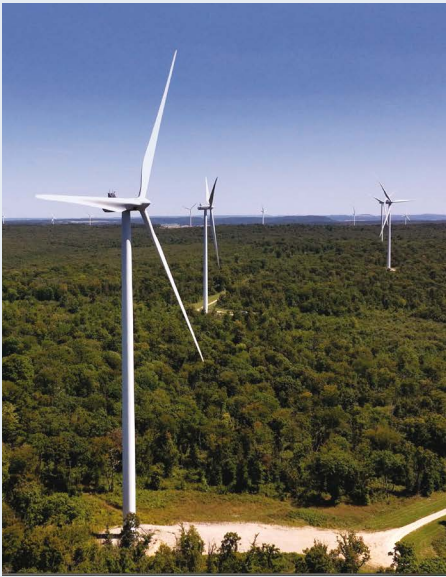
At the Dainville Wind Park in France, Aeronex deployed its Leading Edge Repair (LER) robotic system to carry out repairs on 12 Vestas V110 wind turbine generators (WTGs) for client TotalEnergies.

The main objective was to perform leading edge repairs with maximum efficiency while maintaining safety and consistent quality standards. The category of erosion for all 36 blades was up to CAT 3, with no lamination required for any of the blades.

Aeronex used its proprietary leading-edge repair robotic technology. After a thorough blade assessment, the blades underwent sanding and grinding, followed by cleaning and filler application. Based on performance considerations, LEP 10 was selected as the preferred leading-edge protection coating.

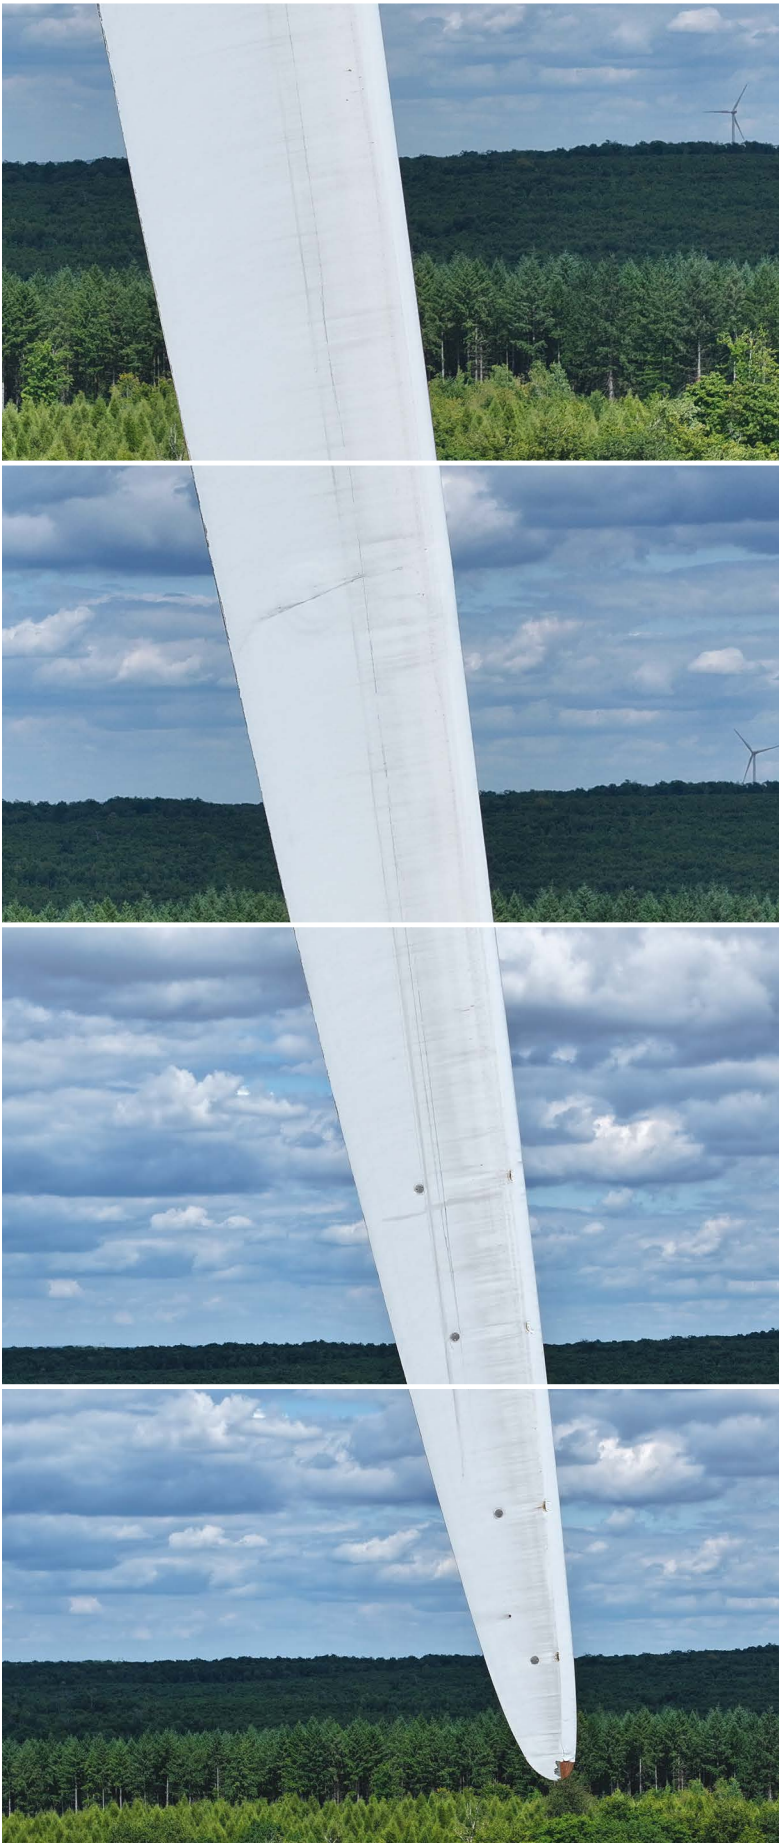
Average time spent on a blade during project -

4h 40* minutes

* includes curing delay idle

Compared with conventional repair methods, Aeronex' robotic system demonstrated a significant reduction in repair time, particularly in the preparation and curing stages, as shown in the chart above.

Aerones robots achieved over 100% faster repair times compared to traditional methods.
